# Manhole Inspection Summary

Manhole # S4300\_005MH

Insp Date: **12/11/07 9:29 AM**

**Location** Address: **Darley Ave**

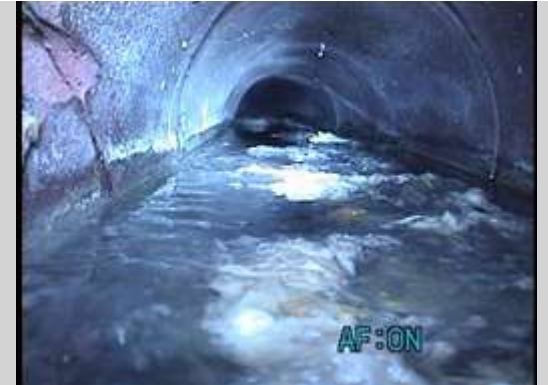
12 O'Clock Outflow

10 in. Circular Gravity Sewer  
Pipe Out @ 12 O'Clock

Pipe Height: **10.8** (in.) Rod and Bar (Angled)  
Pipe Material: **Clay** ☐ Pipe Lined  
Invert Depth: **8.85** (ft.) Flow Characteristics: **Slow**  
Deposits: ☒ None ☐ Mud ☐ Sludge ☐ Debris ☐ Grease  
Silt Depth: (in.) Deposits Extent:  
Infiltration: **None** Pipe Seal Cond: **Sound**

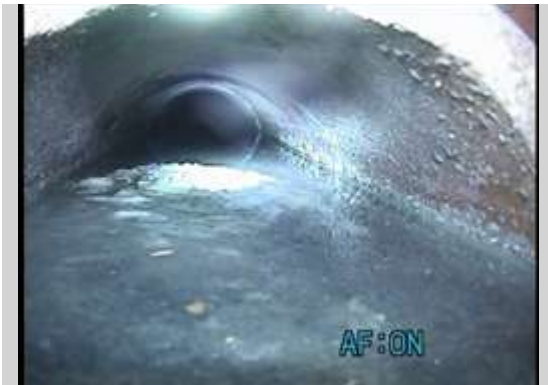
5 O'Clock Inflow

10 in. Circular Gravity Sewer  
Pipe In @ 5 O'Clock

Pipe Height: **8.4** (in.) Rod and Bar (Angled)  
Pipe Material: **Clay** ☐ Pipe Lined  
Invert Depth: **8.80** (ft.) Flow Characteristics: **Slow**  
Deposits: ☒ None ☐ Mud ☐ Sludge ☐ Debris ☐ Grease  
Silt Depth: (in.) Deposits Extent:  
Infiltration: **None** Pipe Seal Cond: **Sound**

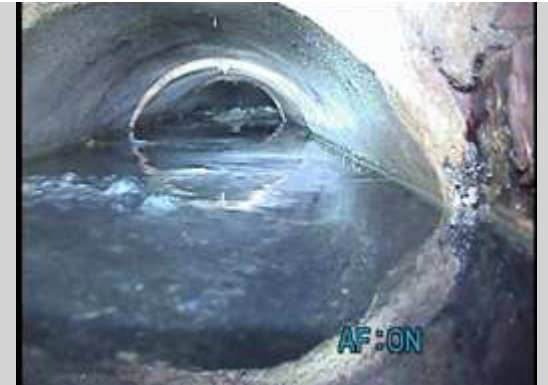
6 O'Clock Inflow

10 in. Circular Gravity Sewer  
Pipe In @ 6 O'Clock

Pipe Height: **8.4** (in.) Rod and Bar (Angled)

Pipe Material: **Clay** ☐ Pipe Lined

Invert Depth: **8.60** (ft.) Flow Characteristics: **Slow**

Infiltration: **None** Pipe Seal Cond: **Sound**
